# Side-by-Side Study Proves SIP Advantage

## Brock University study quantifies superior thermal performance of SIPs

**This white paper highlights the findings of recent research by Dr. Tony Shaw of Brock University. Supported in part by the National Research Council of Canada, the year-long study measured heat loss and energy efficiency of two nearly identical residential buildings, one framed with stud and batt exterior walls, the other built with Structural Insulated Panels (SIPs). Using several methodologies, the research quantified the superior thermal performance of SIP construction.**

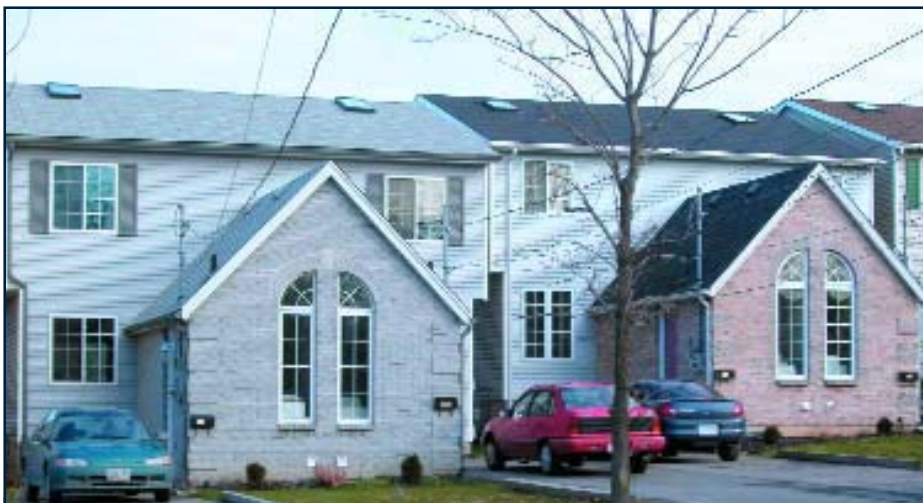
Dr. Tony Shaw of Brock University compared the thermal efficiency of two units in these nearly identical semi-detached homes. The house on the left was built with SIPs, while the other was framed with studs and batt insulation.

The two structures involved in the study were rental housing units, located immediately adjacent to one another. Both buildings were identical and had similar east-west orientations, ensuring the same exposure to outdoor temperature and wind conditions. Except for brief periods both houses were occupied throughout the course of the study, which took place over a 12-month period from February 2000 to January 2001. Both units were heated with a natural gas / forced air system.

One unit was constructed with 4.5" SIPs, while the other used 2x6 studs with batt insulation. Both houses were constructed according to the Ontario Building Code (OBC). The units were built by the same crews, with no one being aware that scientific tests would be conducted afterwards.
